CNGS: Status and Outlook

Edda Gschwendtner, AB/ATB

- **Summary of CNGS 2006**
- **Reflector Repair**
- **OPERA Brick Production**

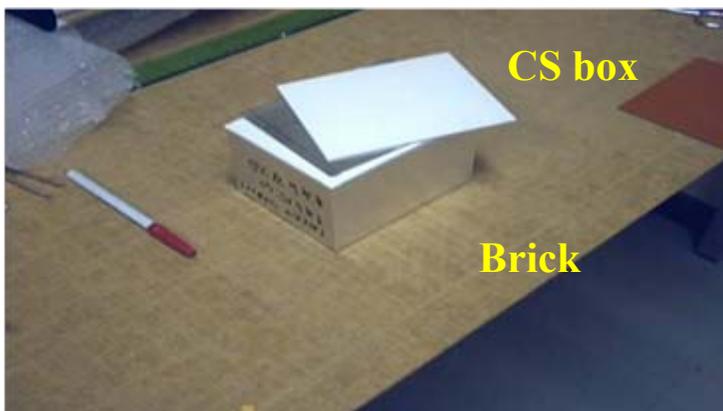
BAM wrapping section

CS box

Brick

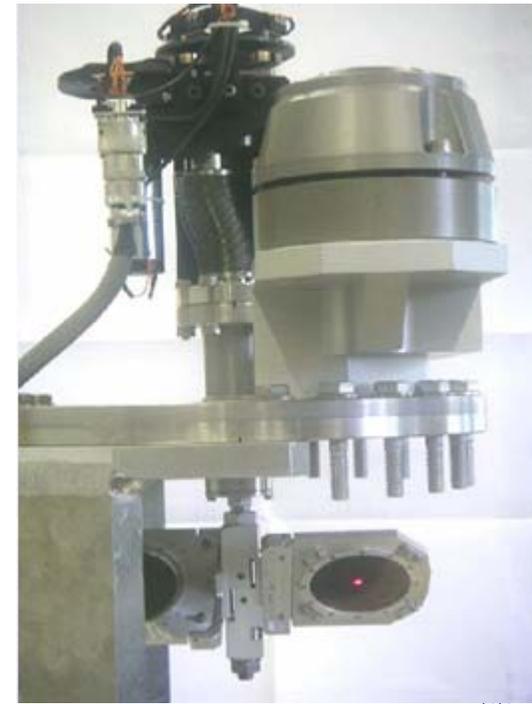
FIRST SHOT 11 July 2006

1st shot down proton beam line: beam is already well centered on screens

8 profile monitors (BTVG):

Optical Transition Radiation screens:

- 75 μm carbon
- 12 μm titanium screens

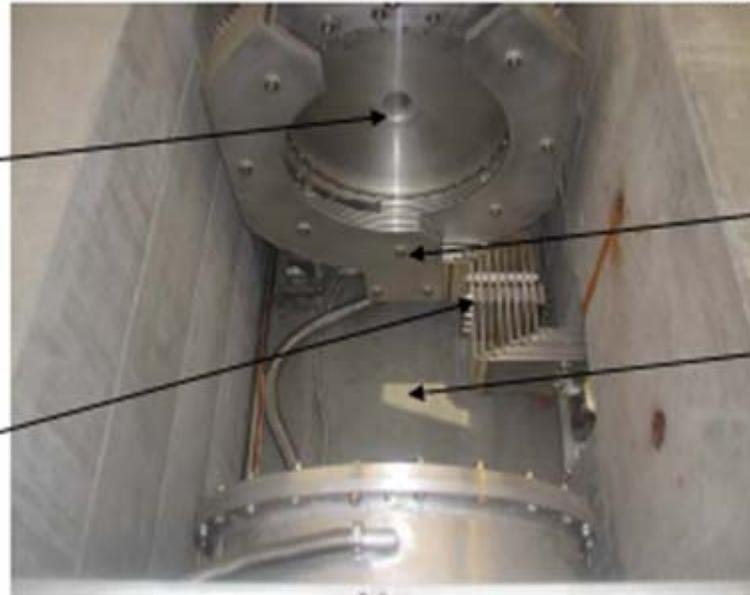
Radiation Levels inside Reflector Shielding

1500 $\mu\text{Sv/hr}$

2900 $\mu\text{Sv/hr}$

1700 $\mu\text{Sv/hr}$

700 $\mu\text{Sv/hr}$

Radiation x 5 for the horn
