CNGS: Status and Perspectives for 2007

Edda Gschwendtner , CERN, Geneva

CERN NEUTRINOS TO GRAN SASSO

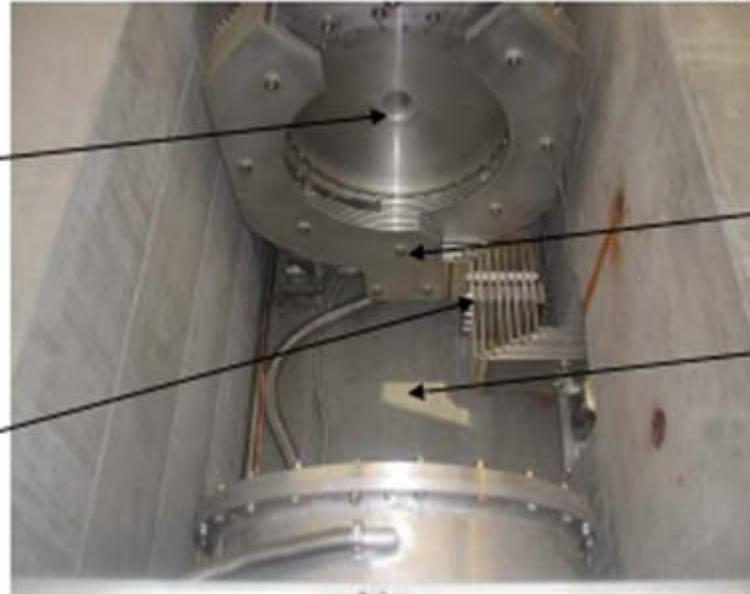
Radiation Levels inside Reflector Shielding

1500 $\mu\text{Sv/hr}$

2900 $\mu\text{Sv/hr}$

1700 $\mu\text{Sv/hr}$

700 $\mu\text{Sv/hr}$

Radiation x 5 for the horn
