CNGS Operation Results in 2007

Edda Gschwendtner, AB/ATB

- Modifications done during 2007 for the Horn and Reflector
- CNGS Run 2007

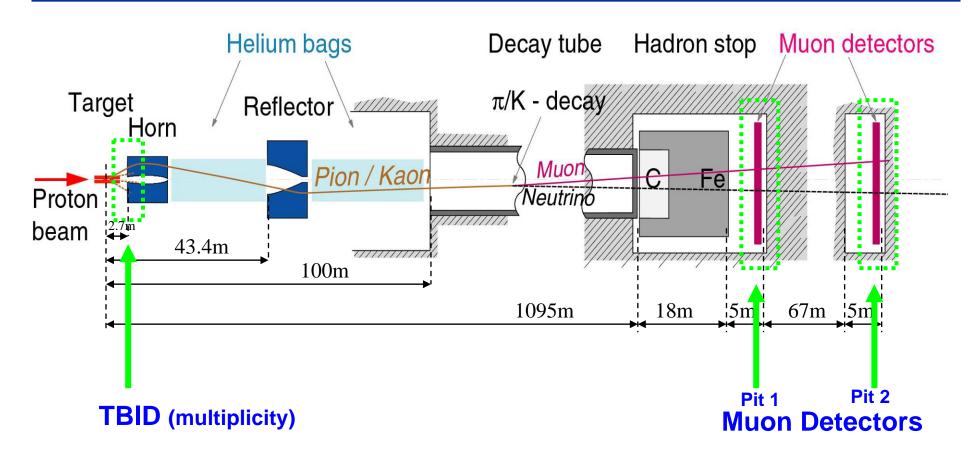
CNGS Layout

p + C
$$\rightarrow$$
 (interactions) \rightarrow π^+ , K⁺ \rightarrow (decay in flight) \rightarrow μ^+ + ν_{μ}

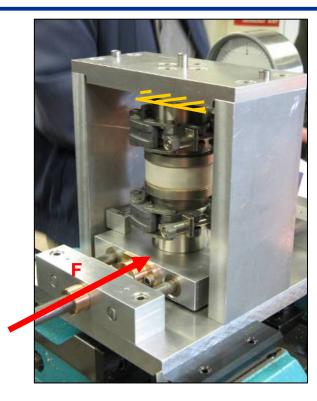
1.) Water Outlet

Reason for Leaking Water Outlet:

Destructive test:

- Failure during destructive test at machined edge at small force: ~10MPa
- Rupture limit of ceramic under bending/traction:
 ~300MPa

- Brazing + machining induce stress equivalent to
 ~95% of ceramic stress limit
- Brazed assembly is at limit of failure
- Design not reliable (brazing, machined ceramic)

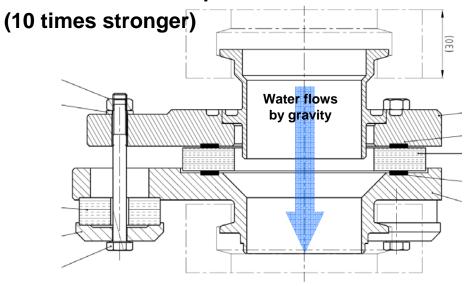
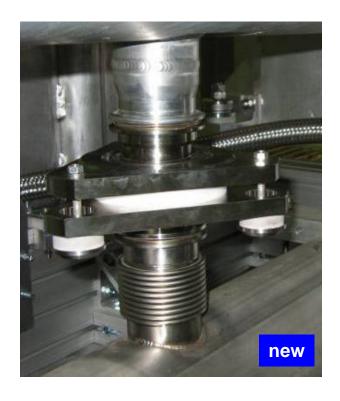
Design of New Water Outlet

Stress in ceramic strongly reduced:

- No brazing
- No machined internal edges
- Ceramic under compression

- Thorough technical study
 - Detailed validation/calculations of the new design
 - Additional features optimized

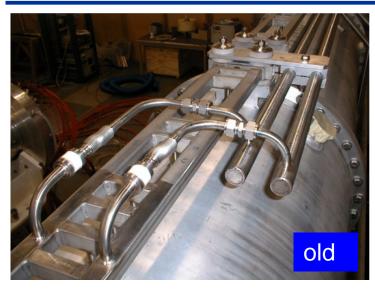
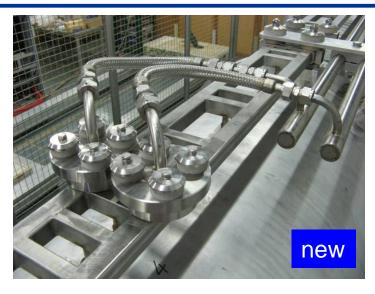
Water Inlet on top of the Horn / Reflector

→ Water inlet circuit not broken, but got 'enhanced'

- Long & thin bellows
- Stainless steel foil brazed on ceramic sleeve
- Delicate welds
- Pressure: 1.3 bar

- Thin bellows replaced with metallic hoses
- Ceramic as for outlets:
 - No brazing
 - No edges
 - Under compression

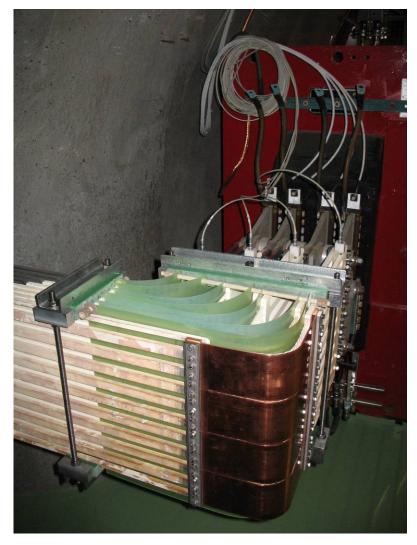
Stripline Modifications for Run 2007

- Insulating sheets installed on the flexible section
 - Protect against short-circuits
 - Installed on horn and reflector
- Put an electrical by-pass in place
 - Ensure that current still flows in case last cable breaks
 - Installed on most outer reflector plate

→ In shutdown 2007/08:
New flexible striplines designed, manufactured and installed.

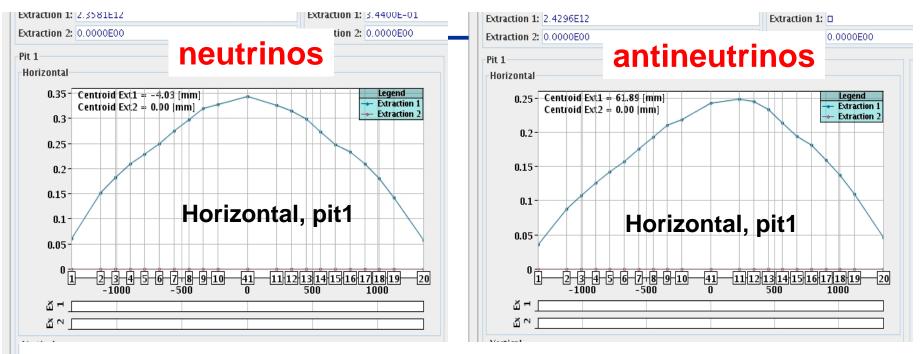
Studies on Neutrino/Antineutrino Behavior

- Many systematic measurements done:
 - Different polarities with different currents in horn & reflector
 - Different target position
 - → analysis ongoing

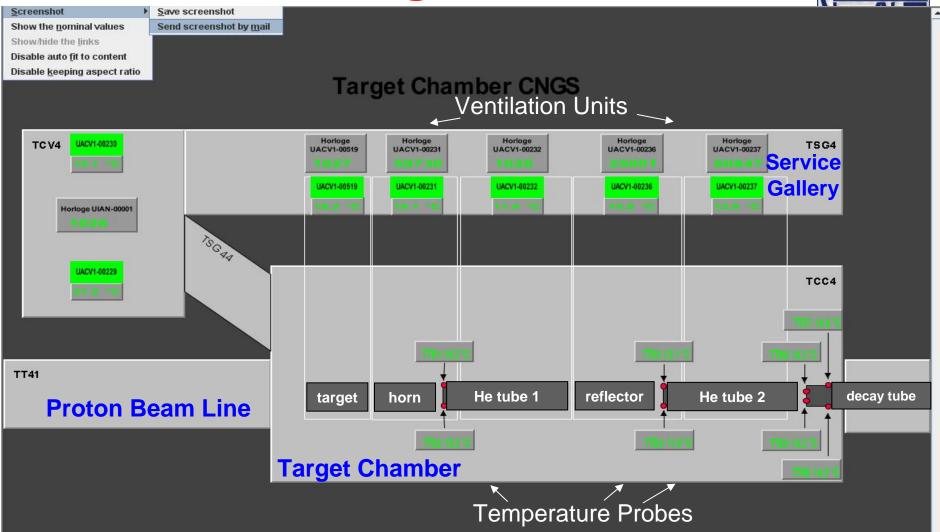
CNGS Target Chamber

Single event upsets in ventilation electronics: caused ventilation control failure and interruption of communication
